Manhole Inspection Summary

Manhole # S01SS1013MH

Insp Date: **9/21/06 7:31 AM**

Location Address: **4003 GLEN AVE**

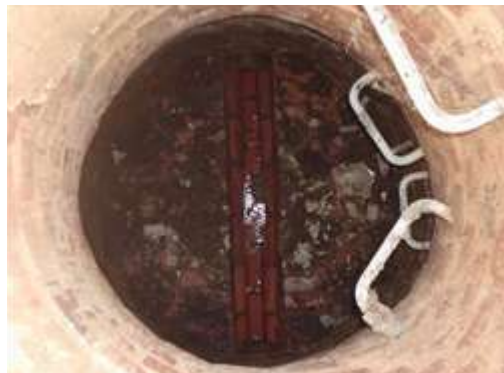
Top View

Adjustment infiltration. Corbel root intrusion and infiltration. Barrel infiltration. Evidence of surcharge - Bench debris.

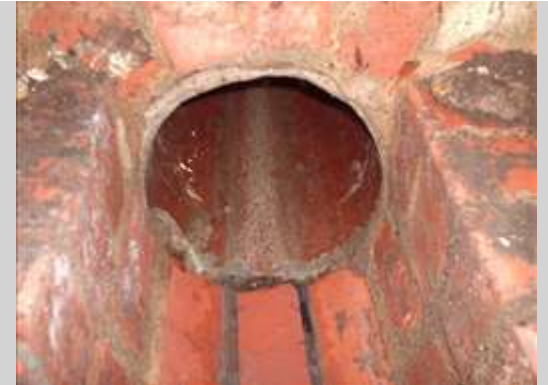
8 in. Circular Gravity Sewer Pipe Out @ 12 O'Clock

Pipe Material: **Unknown** ☐ Pipe Lined

Invert Depth: **9.66** (ft.) Flow Characteristics: **None**

Deposits: ☒ None ☐ Mud ☐ Sludge ☐ Debris ☐ Grease

Infiltration: **None** Pipe Seal Cond: **Unknown**

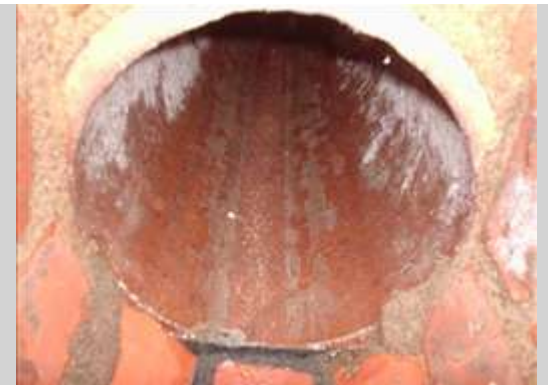
8 in. Circular Gravity Sewer Pipe In @ 6 O'Clock

Pipe Material: **Clay** ☐ Pipe Lined

Invert Depth: **9.59** (ft.) Flow Characteristics: **None**

Deposits: ☒ None ☐ Mud ☐ Sludge ☐ Debris ☐ Grease

Infiltration: **None** Pipe Seal Cond: **Unknown**
